The Warship Hazardous Project Site Report

November 2014.

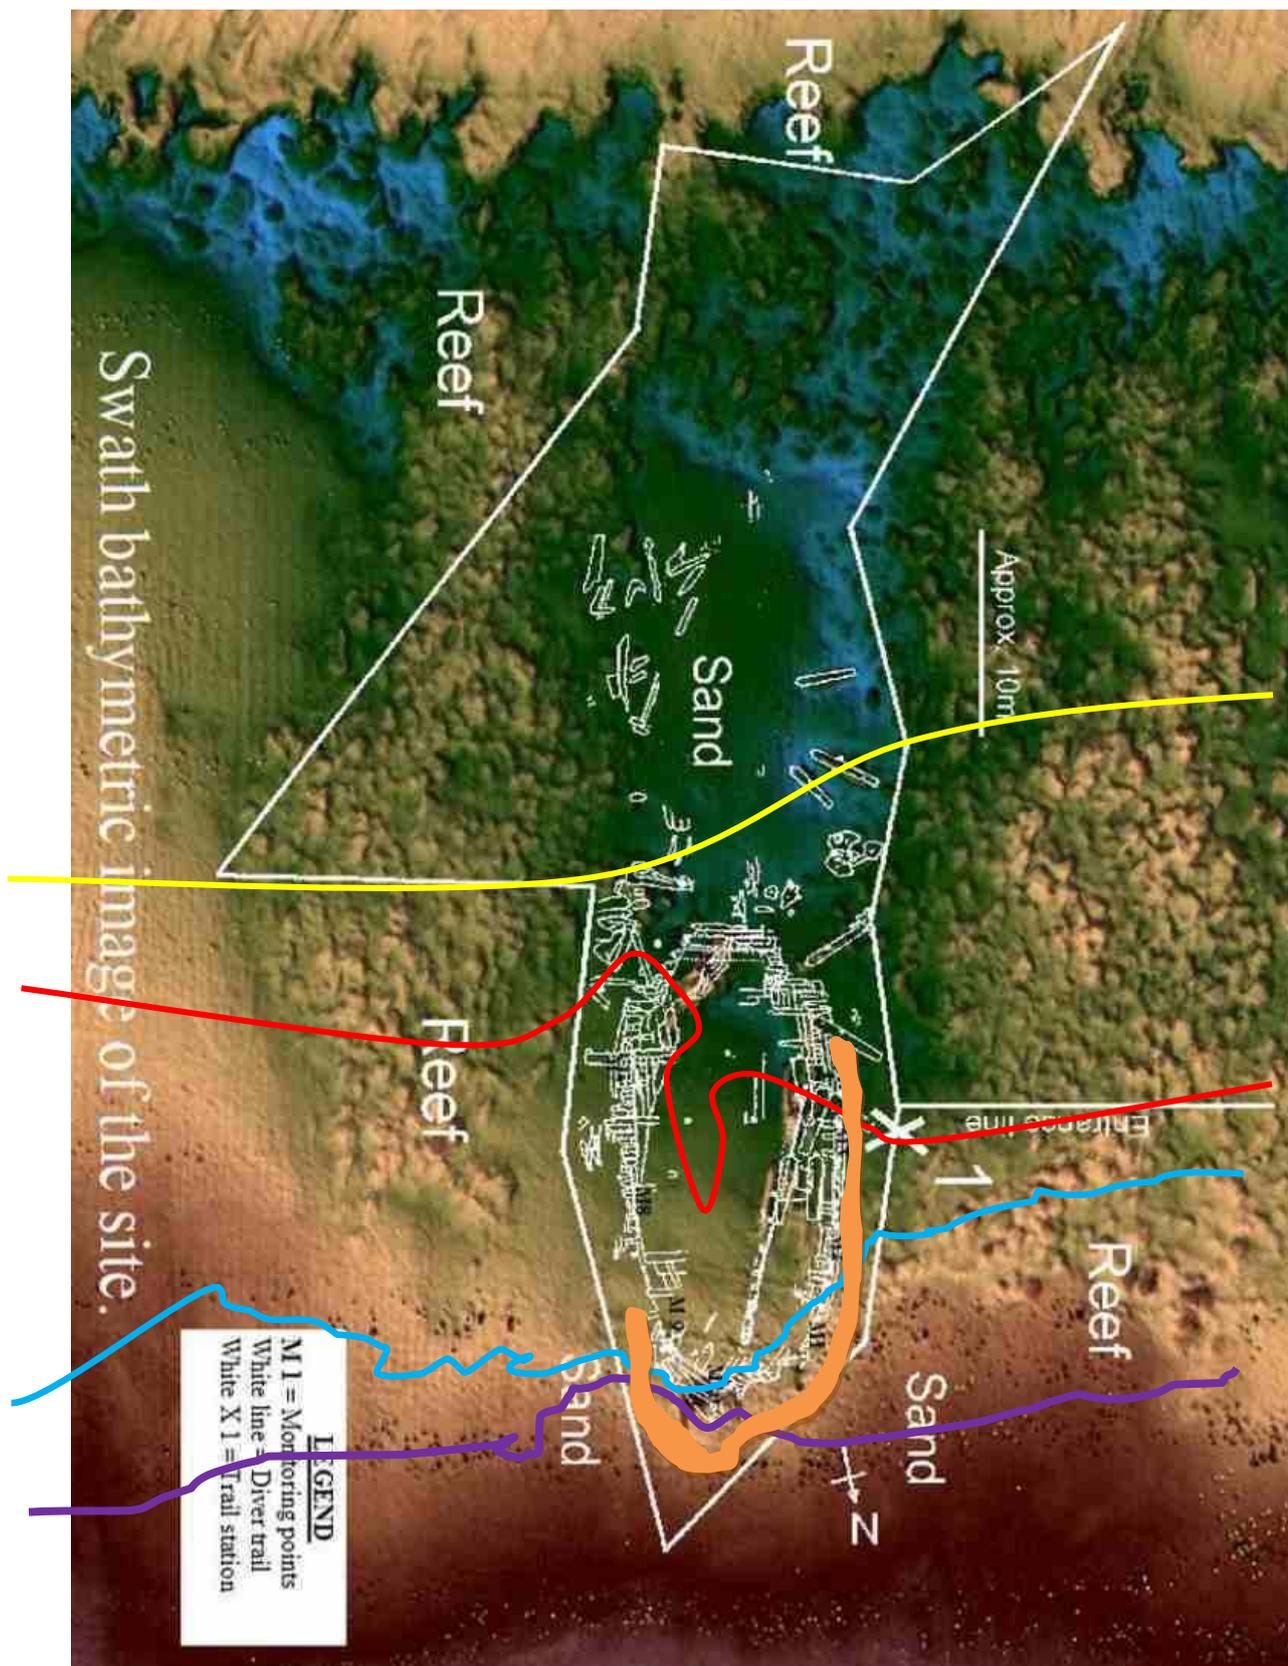
Figure 1. showing site plan & diver trail overlain on past swath bathymetric survey results.

Yellow line = 2008 sand movement from the south to the north.

Red line = 2009 sand movement from the south to the north.

Blue line = sand movement from the south to the north as at 17th October 2010.

Purple line = sand movement from the south to the north as at 21st August 2011.

Light brown = 2013 localized scour.

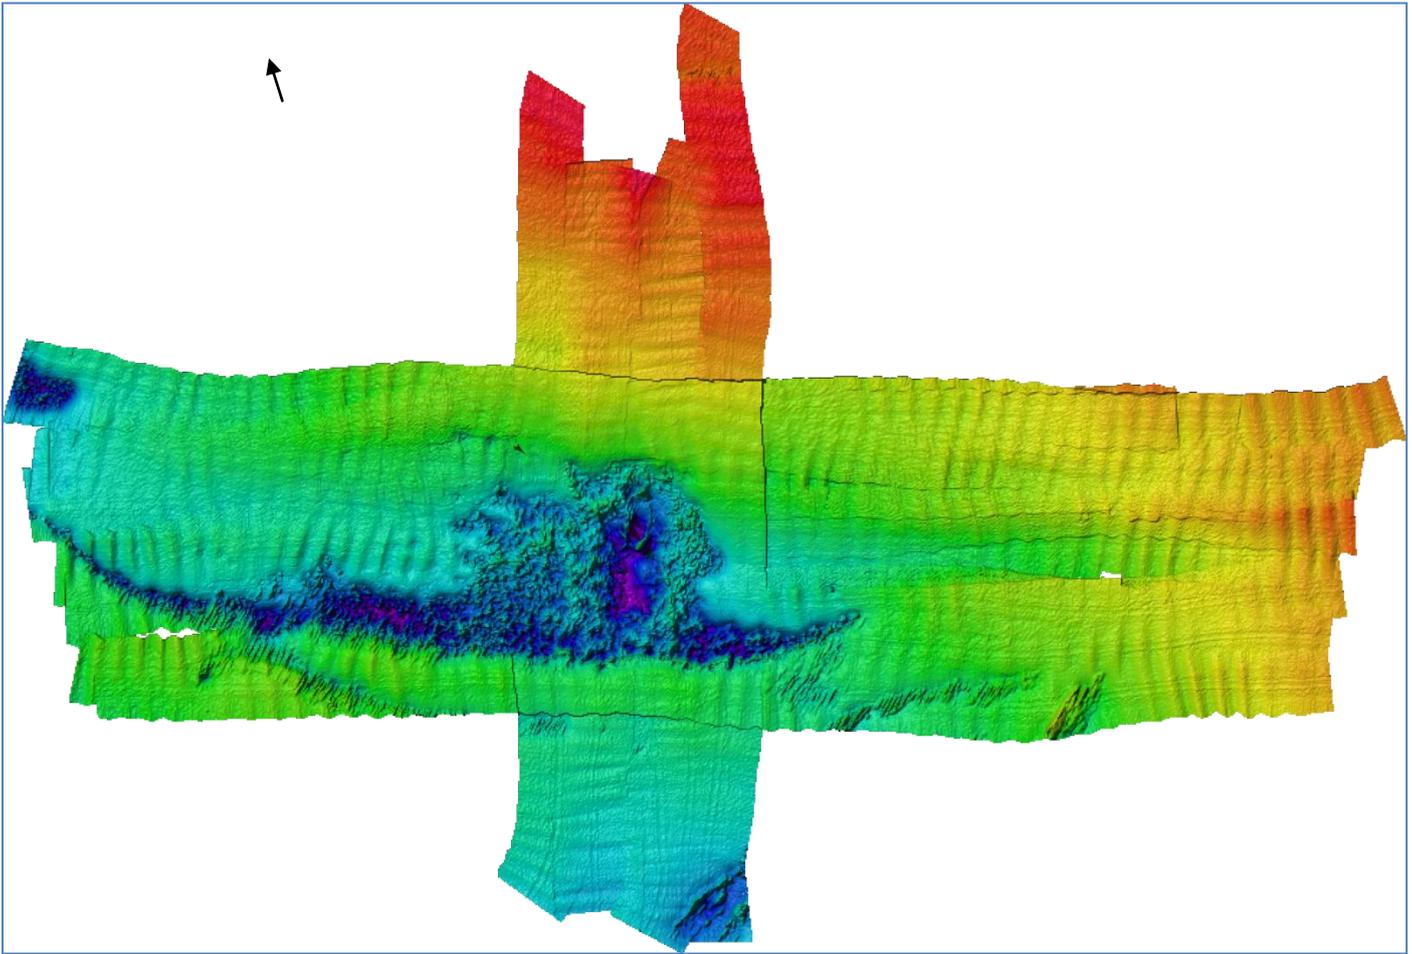
Figure 2. Swath bathymetric survey results July 2014. North up. Showing erosion over the site & out to the west.

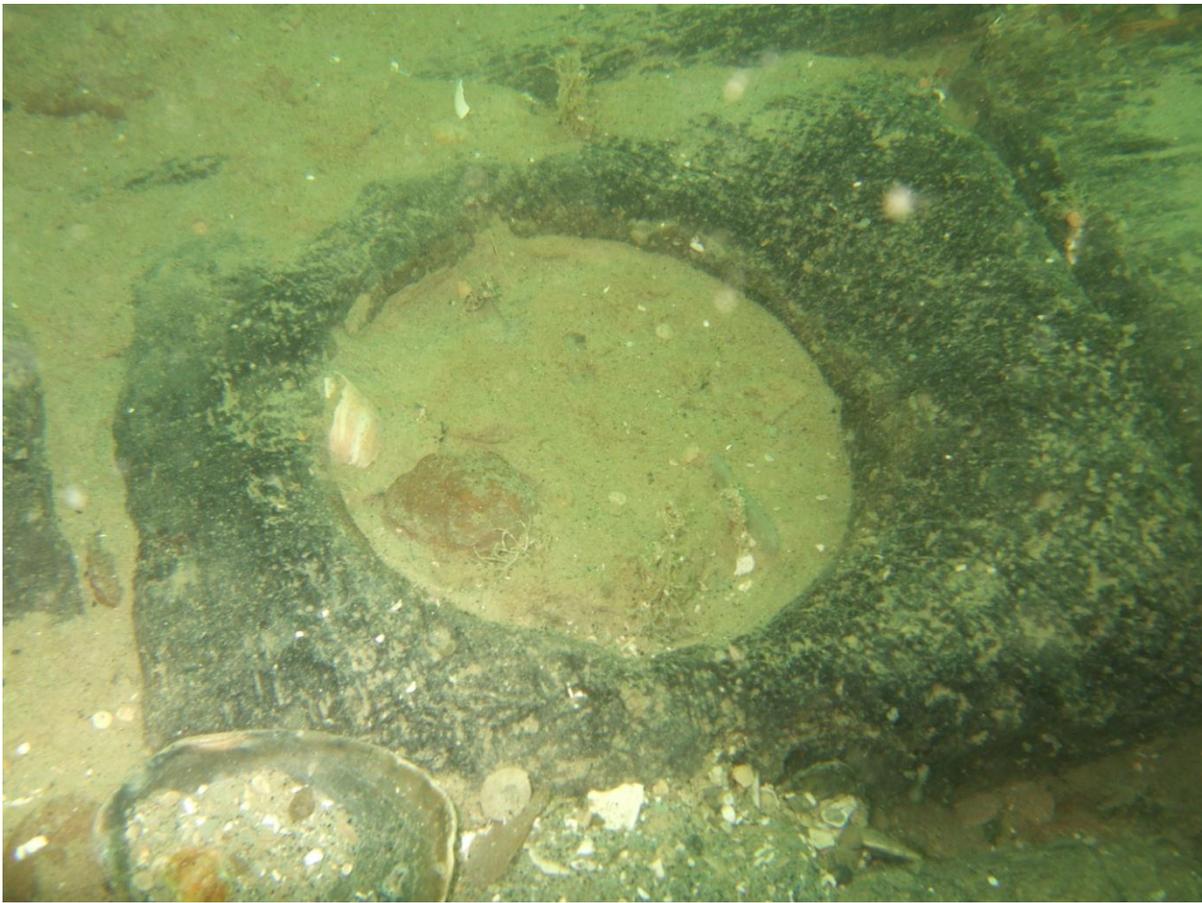
After Dave Johnston set the mooring, Andy & I joined him & had a general look around the site, initial inspection showed a huge reduction in sand overburden along the west side frames & under the guns. The gun & carriage which was sheeted down & buried a number of years ago, is now uncovered completely, the top edge of the gun carriage which when discovered during a trench excavation in the early 1990's was in pristine condition, has now been severely degraded by Gribble worm. The wheels that were in place on the axles may still be covered to some degree affording them some protection, at least for the time being. There are some new features now visible in the internal hull timbers not seen before: *See image below for one example.*

Figure 3. *New feature seen in ships timber, portside near beak.*

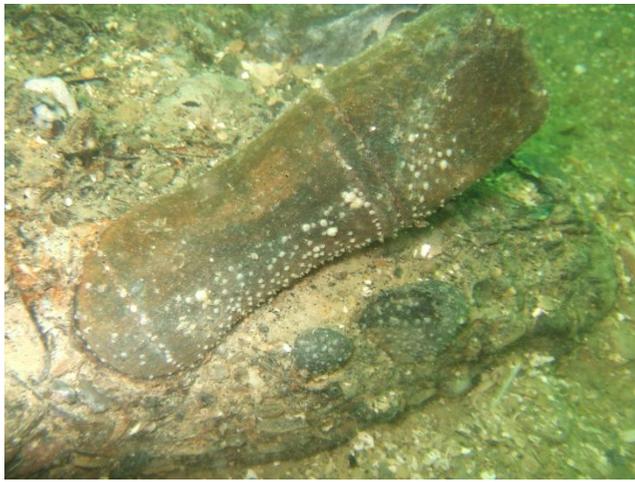
Heading down the east side frames, monitoring point M9 shows a reduction in levels of 70mm since last measured on 25th August 13, however in the general area there has been a reduction of up to half a metre in places, uncovering timbers in pristine condition not seen by the author in thirty years diving on the site. There are also a number of artefacts now visible, such as a turned wooden object, small concretions, bone, small lead tangles & a large section of lead sheeting along with concreted iron: *See figures 4-6 below.*

Figure 4. Carved wooden object.

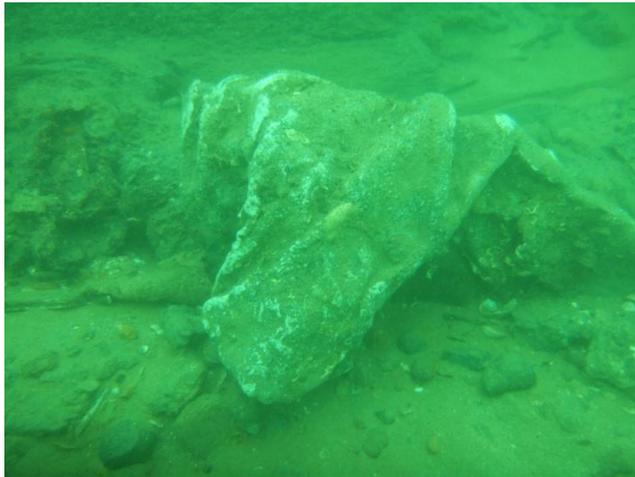
Figure 5. Large section of lead.

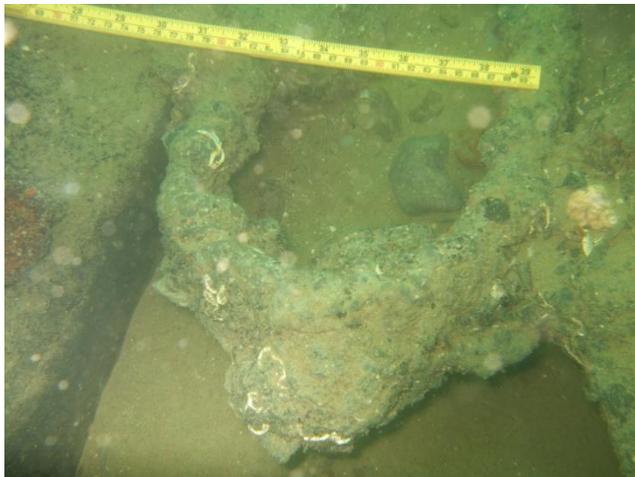
Figure 6. Concreted iron between frames.

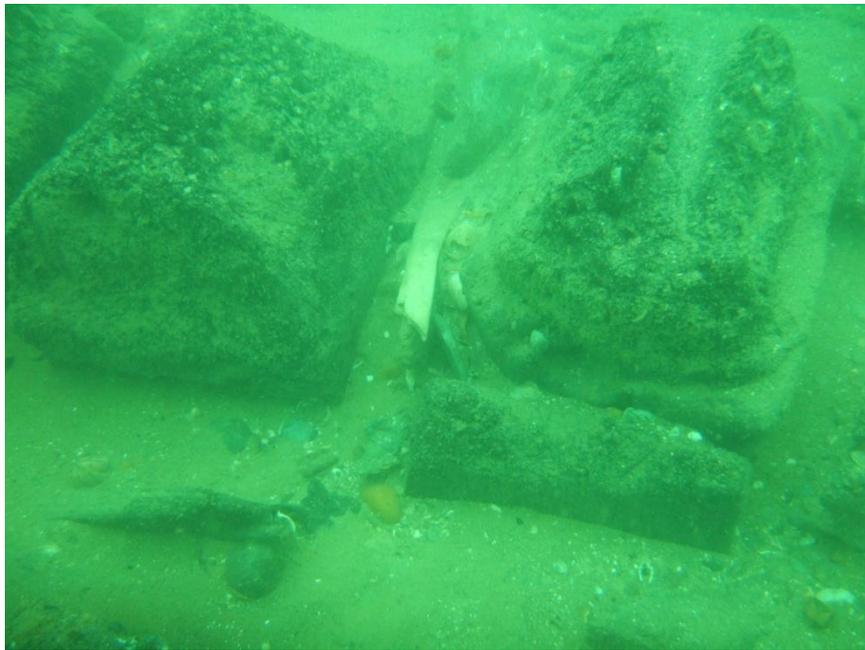
Figure 6. Animal bone in between frames.
